# **West Lake Landfill Vicinity**

**Radiological Survey and Sampling**

**November 4-6, 2015**

**Final Report**

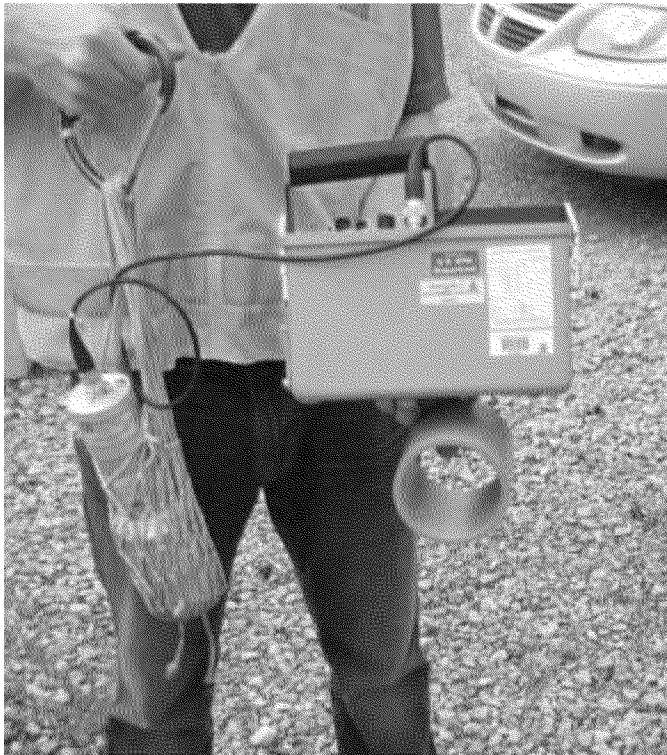
EPA Equipment Y: Ludlum model 2221 with 44-20 NaI Gamma Scintillator detector – This field equipment was brought by and periodically used by EPA personnel at some sampling locations(Photograph 1.)

**Photograph 1: EPA Ludlum 2221 with NaI 44-20 detector and directional shield attachment (EPA Equipment Y)**

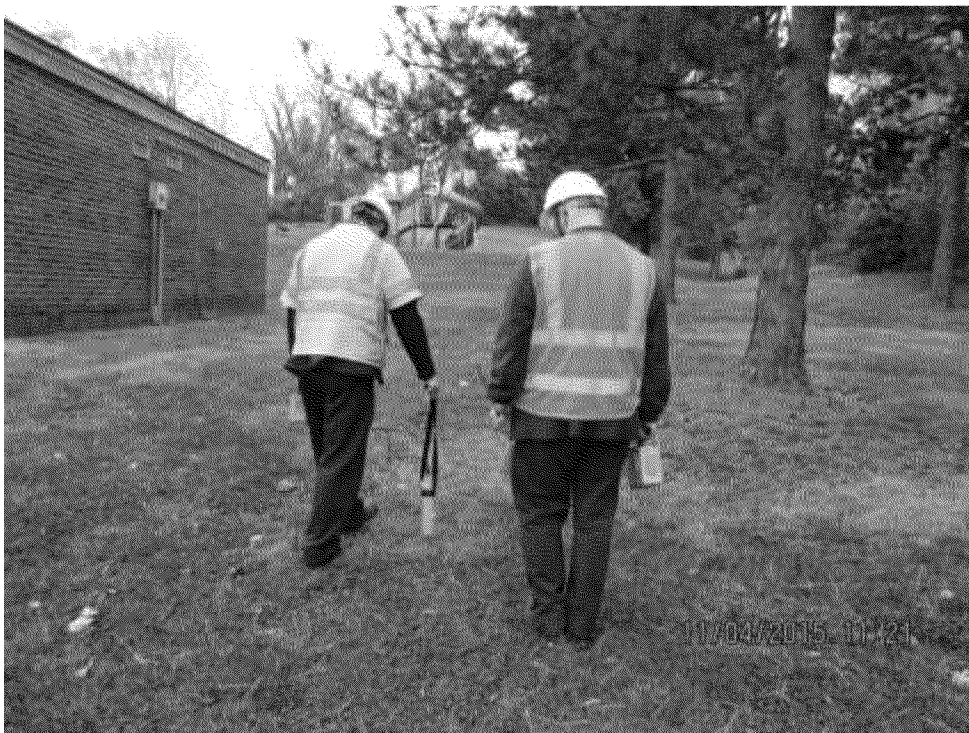
**Photograph 2: Gamma walkover survey conducted at Spanish Village Park**

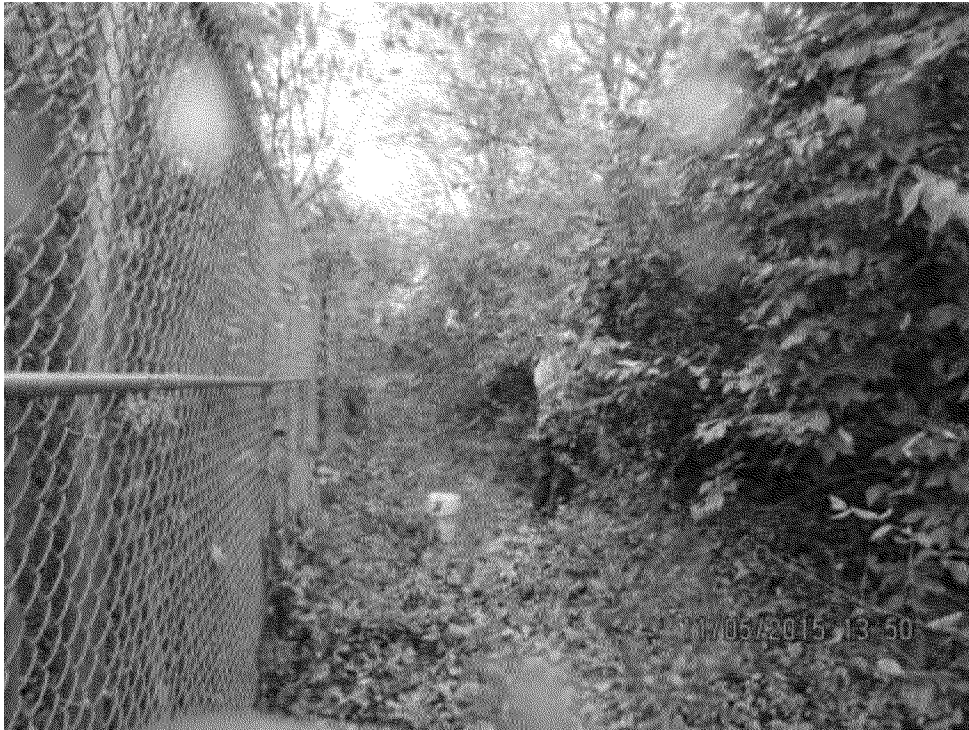
Total radionuclide activity in soil sample S09 were comparatively higher than total activity found in most other samples, and also exceeded EPA unrestricted use level for Th-230+232. Nearly half of the laboratory detected activity is associated with the Th-230 isotope. Soil sample S09 is located in proximity to soil sample S10 and dust sample D07, with all samples being on private property. Data suggest that RIM is present in sample S09, and further investigation in the area surrounding sample location S09 is warranted.

**Photograph 3: One minute count being conducted on equipment B following gamma survey of immediate area. These locations are flagged in preparation of final soil sample location S09**

1. Recommendation Requiring Additional Site Characterization; Soil Sample locations S09 & S10: Survey and sample data suggests that the area located immediately northwest of, and adjacent to OU-1 Area 2 requires additional characterization. The supporting data includes persistent comparatively higher values from gamma surveys, comparatively higher alpha and beta activity on dust swipe sample D07A, and soil sample results from S10, and S09 that exceed EPA's unrestricted use levels. These sample results can supplement on-going characterization activities by incorporation into any additional investigation conducted by EPA and the PRPs. This conclusion is consistent with the need for additional investigation identified in EPA's 2008 OU-1 Record of Decision (EPA 2008.)

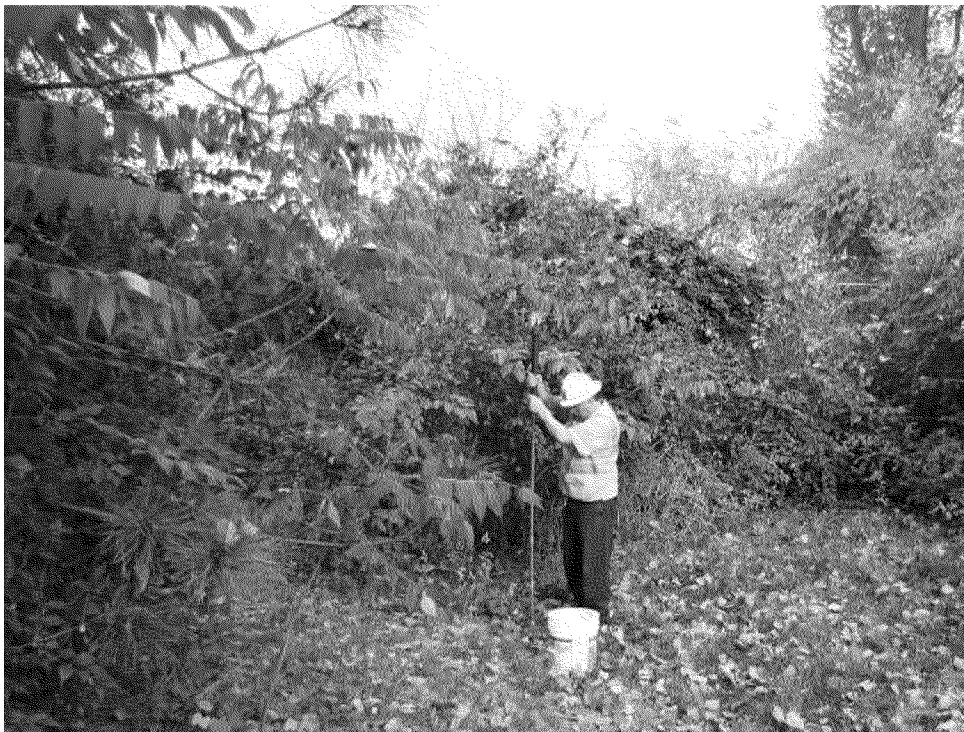
**Photograph 4: Soil sampling with Split Spoon sampler**

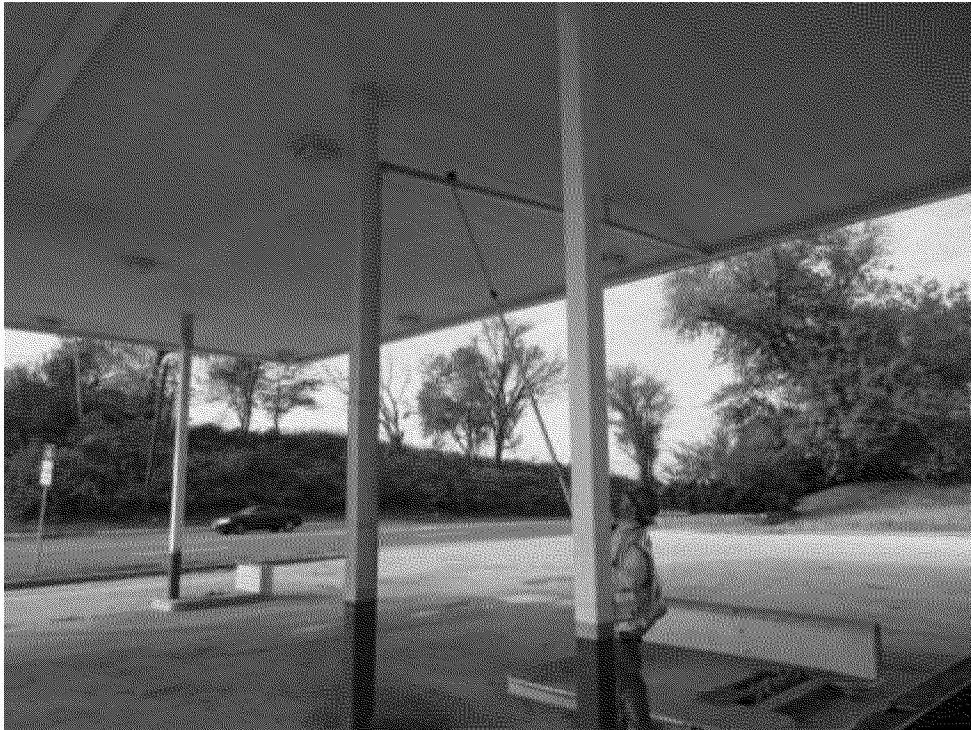
**Photograph 7: Collection of dust swipe sample D02A**
